## Matthew Jones House

Historic Maintenance and Repair Manual

### **Final report**

Under   Project # 396574, "Matthew Jones House Maintenance & Repair Manual."

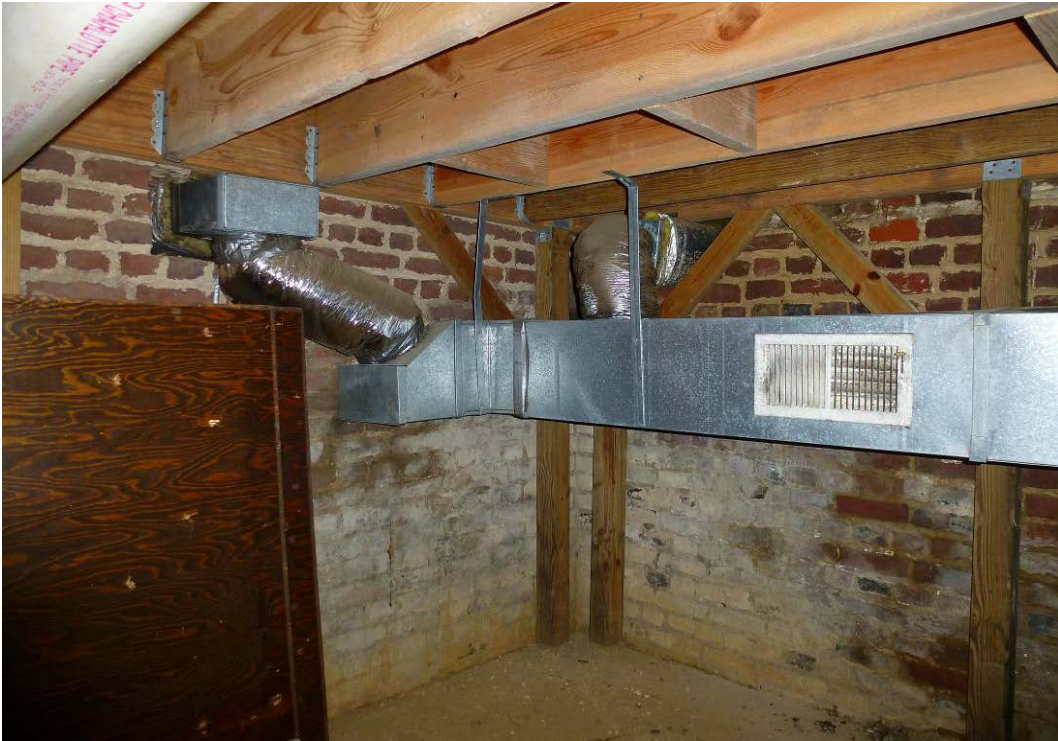
Figure 216. Either water from the ground or condensation from the HVAC system is damaging the brick cellar wall; damage is evident from the white appearance of the brick (ERDC-CERL, 2012).

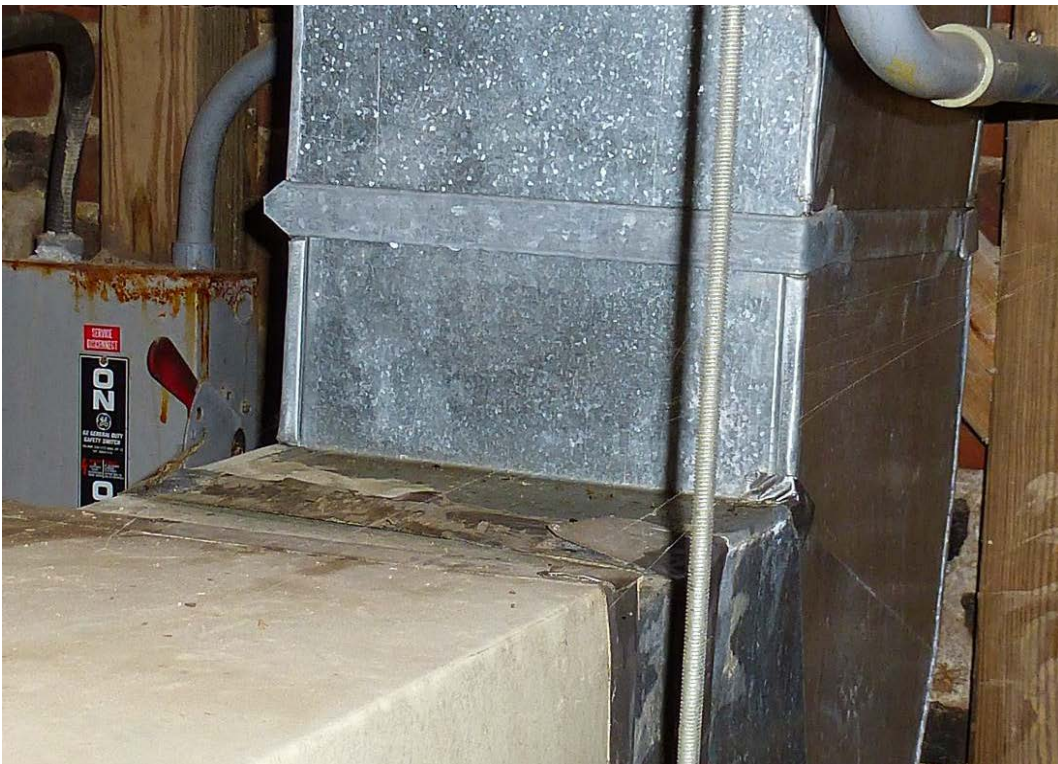
Figure 217. One of the HVAC vents is insulated, but the other is not (ERDC-CERL, 2012).

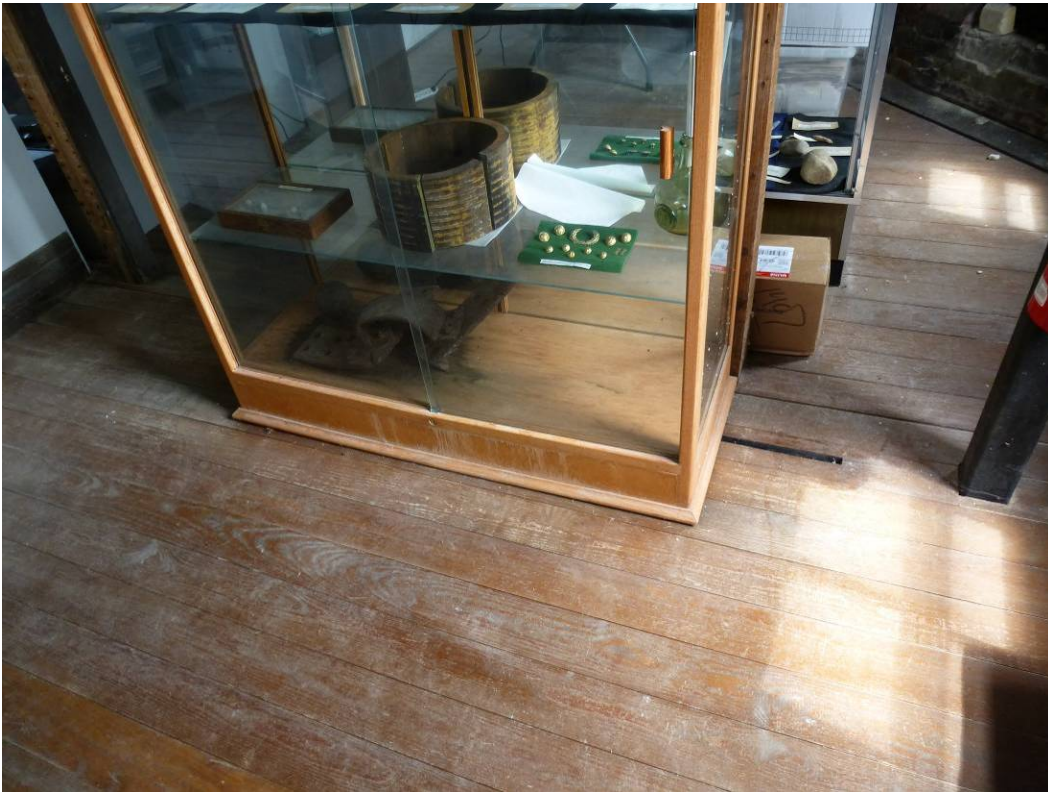
Figure 220. Cabinet should be moved off of the slit vent in the floorboard (ERDC-CERL, 2012).

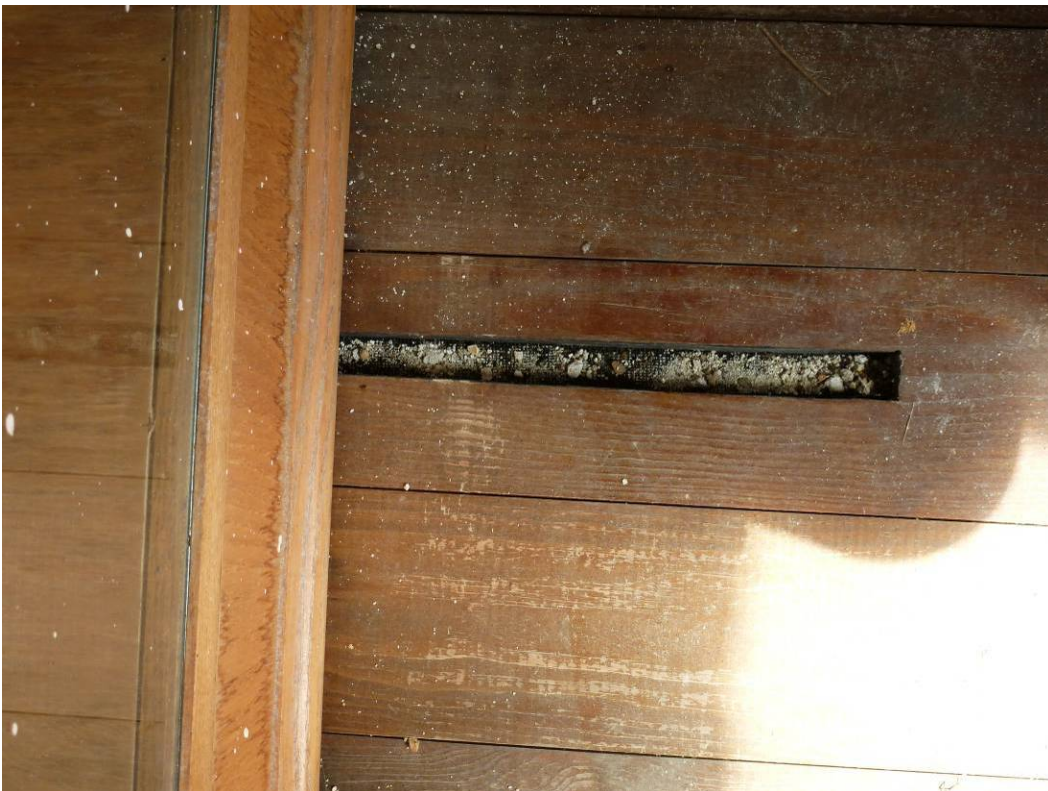
Figure 221. Debris should be cleaned out from all vents (ERDC-CERL, 2012).

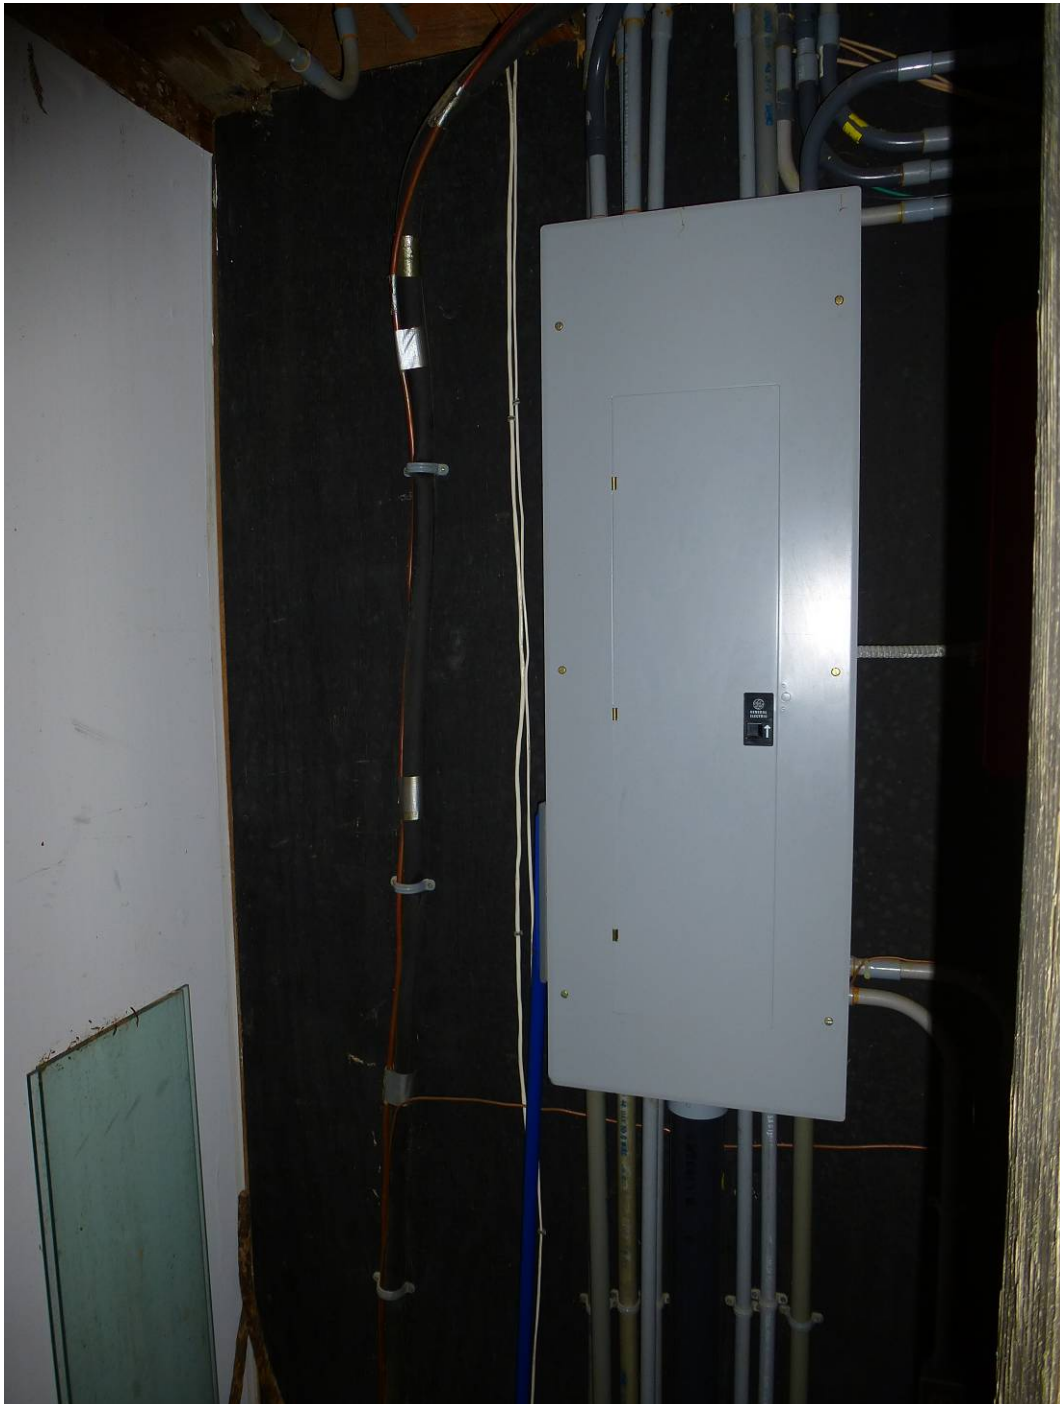
Figure 222. Electrical box is located in the small closet under the stair passage (ERDC-CERL, 2012).

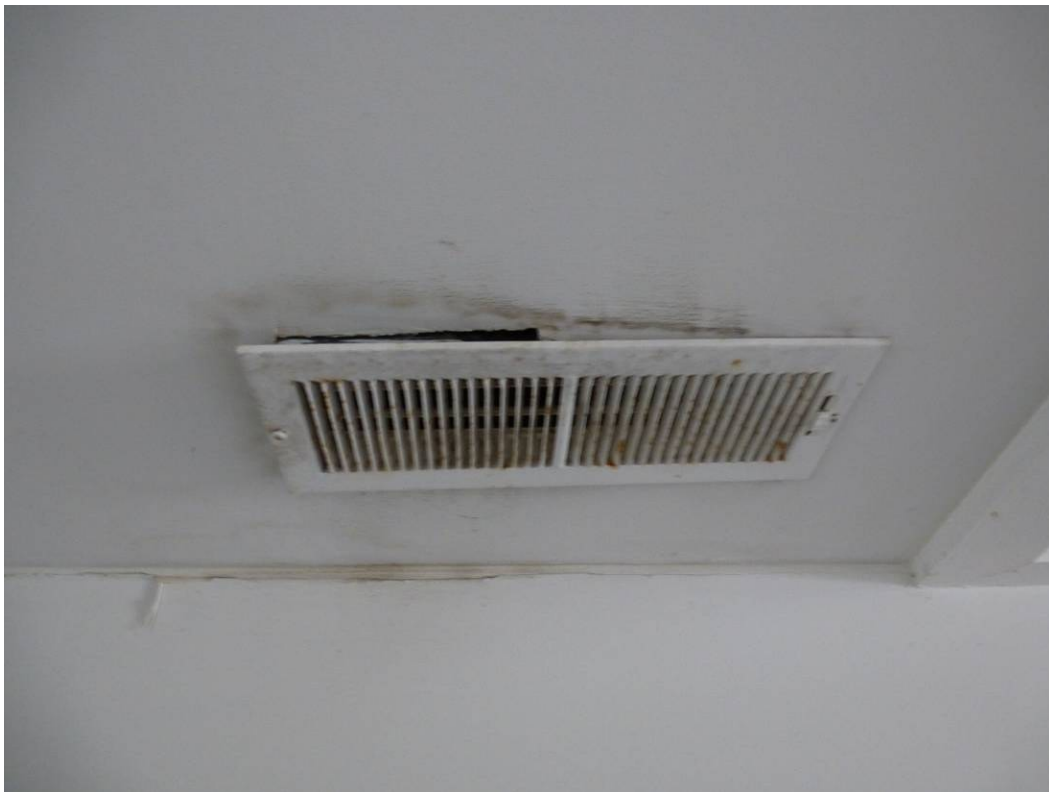
Figure 223. Ceiling vent in the second-floor chamber above the dining room. Vent is not properly attached, and mold is evident (ERDC-CERL, 2012).

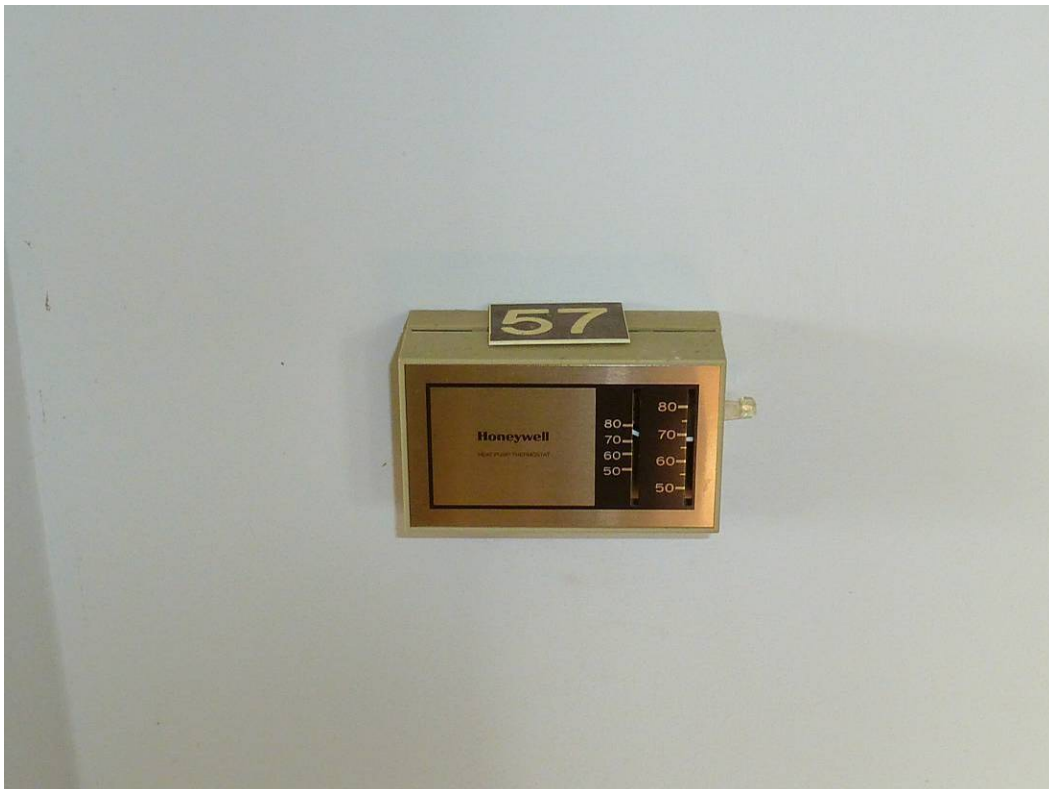
Figure 224. Current thermostat controlling the HVAC system (ERDC-CERL, 2012).

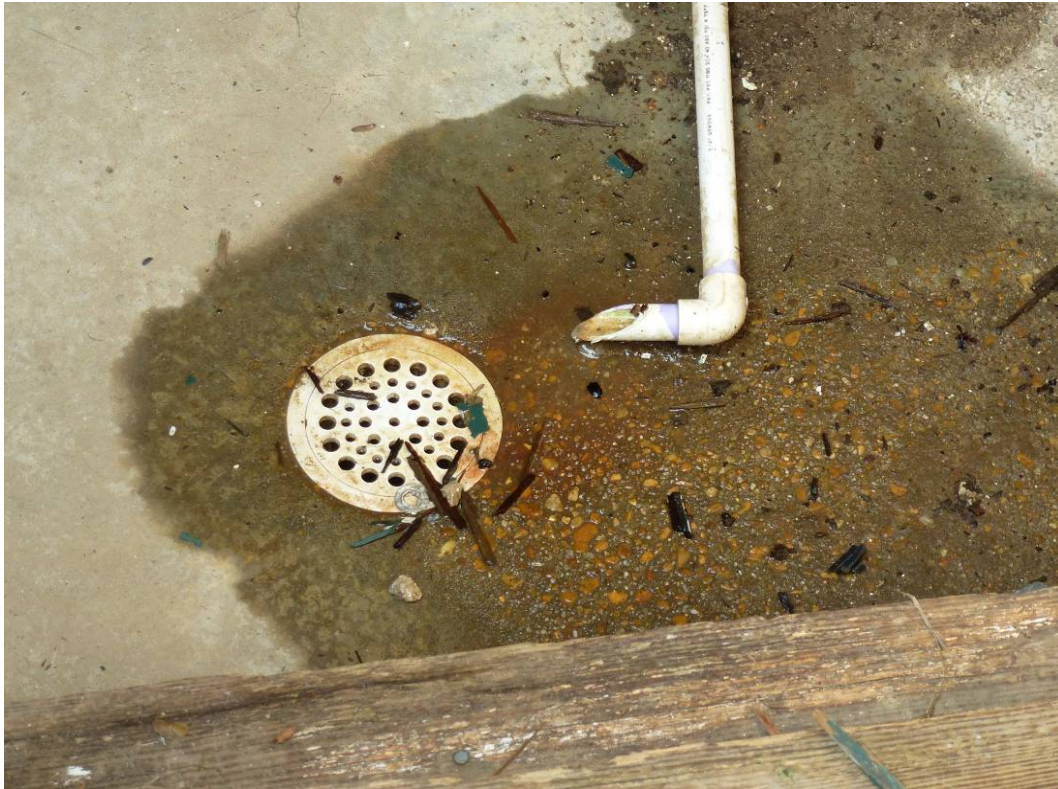
Figure 225. Water is being allowed to pool on the concrete cellar floor. The pipe is coming from the HVAC unit but does not meet the drain in the floor (ERDC-CERL, 2012).
